## **Appendix 15.9 Archaeological Testing Report: Ringfort and Souterrain (CSS 0303 and 0304) at Burnfort, Co. Cork**

**M20 CORK-LIMERICK MOTORWAY EIS**

ARCHAEOLOGICAL ASSESSMENT  
 OF RINGFORT (CO042-051001)  
 BURNFORT TOWNLAND, CO. CORK

EXCAVATION LICENCE: 09E006

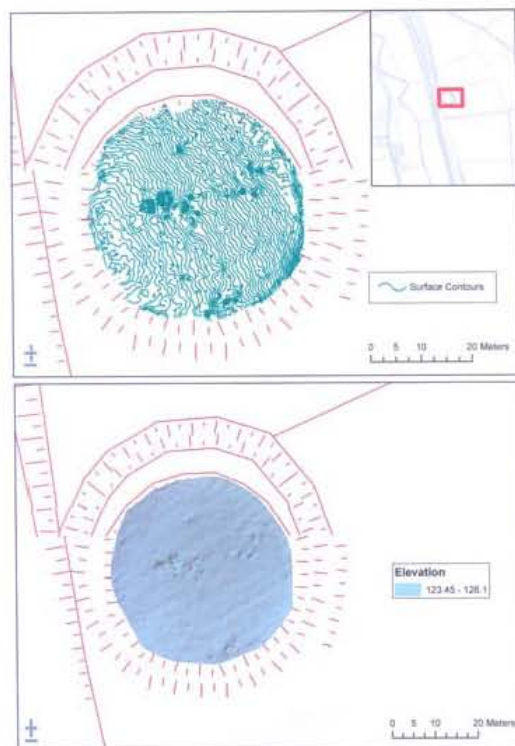
Figure 4. Topographical survey of ringfort.

- 2.4 The initial investigations at the ringfort involved the carrying out of a high resolution topographical survey of the ringfort ground surface, in an attempt to check for any evidence of depressions arising from possible grave subsidence. No such evidence was noticed in the survey results (Fig. 4). However, south-west/ north-east linear trends were noted crossing the ringfort interior and these mirror similar linear anomalies noted in the geophysical survey (Fig. 8).

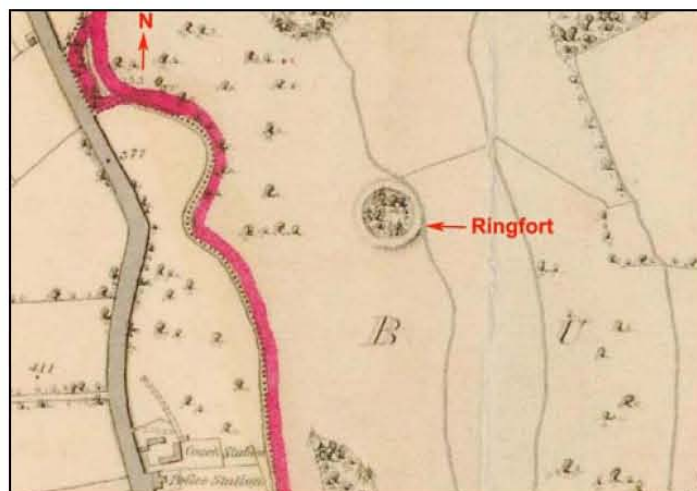
Figure 5: Extract from 1<sup>st</sup> edition OS map (1844)

3.3 The Burnfort ringfort site is depicted on the 1<sup>st</sup> (1844), 2<sup>nd</sup> (1903) and 3<sup>rd</sup> (1935) editions of the Ordnance Survey (OS) maps for the area. The 1<sup>st</sup> edition map shows a circular ringfort with a wide bank and a ditch to the south and south-east (Fig. 5). The ringfort interior is filled with trees. The 2<sup>nd</sup> edition and 25" OS map of 1903 show a similarly tree-filled enclosure with a wide bank and a distinct ditch on all but the southern side of the enclosure (Figs 6, 7). The 3<sup>rd</sup> edition OS map shows the hachures of the ringfort bank. The word 'souterrain' is written across the ringfort obscuring the centre of the fort, but three trees are shown within the enclosure indicating that the ringfort was still planted with trees in the 20<sup>th</sup> century (Fig. 2). A field boundary shown extending north and south along the east side of the ringfort on the 1<sup>st</sup> edition of the OS map is no longer visible today. Both 1<sup>st</sup> and 2<sup>nd</sup> edition maps show a curved field boundary extending ENE from the north-east quadrant of the ringfort. This boundary remains in place today.

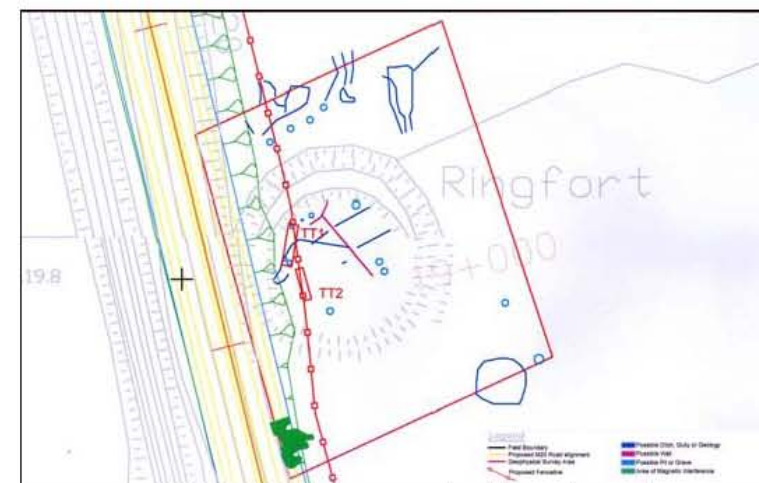
Figure 8: Geophysical survey: magnetic gradiometer interpretation.

4.1 A geophysical survey of the ringfort was carried out in February 2009 by Earthsound Archaeological Geophysics in order to determine the possible location of burials on the site and therefore to inform the design of the trench layout for archaeological testing. The magnetic gradiometer data identified several small circular anomalies and a single linear anomaly in the north-west part of the ringfort interior (Fig. 8). The earth resistance data identified a possible pit and some linear anomalies at the western side of the ringfort enclosure (Fig. 9). Two archaeological test trenches were excavated in the western part of the ringfort enclosure, within the area of the proposed road take, in order to examine the nature of the features identified during the geophysical survey (Fig. 10). Test Trench 1, orientated SSW-NNE, was 15m long and 3m wide and was designed to include three possible pits and a linear feature. Test Trench 2, orientated SSE-NNW, was 15m long and 1.5m wide and was designed to include a possible pit and a linear feature.

- 5.2 There was no evidence of burials in the excavated trenches nor was there any evidence of the pit-like anomalies identified during the geophysical survey. Test Trench 1 was designed to include three circular anomalies and two linear features (Fig. 8). There was a larger amount of stone in the lower levels of the topsoil at the northern end of Test Trench 1 but no definitive feature was identified here to match the circular anomaly at this location. Test Trench 2 was designed to include a single circular anomaly. A small boulder embedded in the soil of one of the furrows (F7) exposed in this trench is close to the area of the circular anomaly. The pre-dominantly south-west/north-east orientation of the furrows identified in both trenches mirrors the linear trends noted in both the topographical and, to a lesser extent, the geophysical surveys. The clear indication of the furrows, and the lack of evidence for burial disturbance in the topographical survey suggests that there may never have been burials within the ringfort interior.

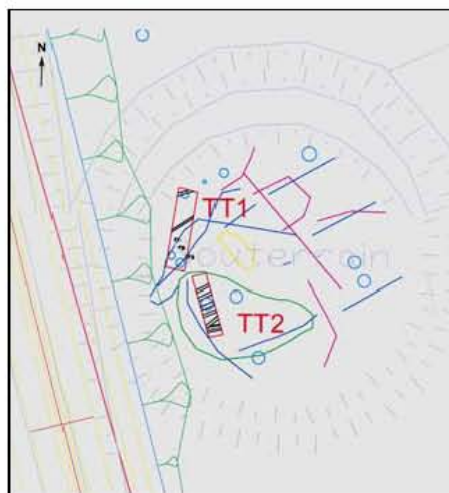
Figure 10: Location of test trenches with features overlaid on geophysical survey results.

A number of features were exposed in the trench (Figs 10, 11; Plates 2-4):

- A stake hole (F1), 0.14m diameter, was exposed in the centre of the southern half of the trench (Plate 2).
- A second stake hole (F2), 0.1m diameter, was exposed towards the southern end of the trench on the east side (Plate 2).
- A possible pit (F3) was exposed extending from the eastern section at the southern end of the trench. This was a semi-circular feature (0.5m diameter) up to 0.3m in depth filled with small stones.
- Two furrows (0.05m deep) extended across the trench in a SW-NE direction (Plate 4). The northernmost furrow (F5) was 0.7m wide and that to the south (F4) was 0.53m wide.

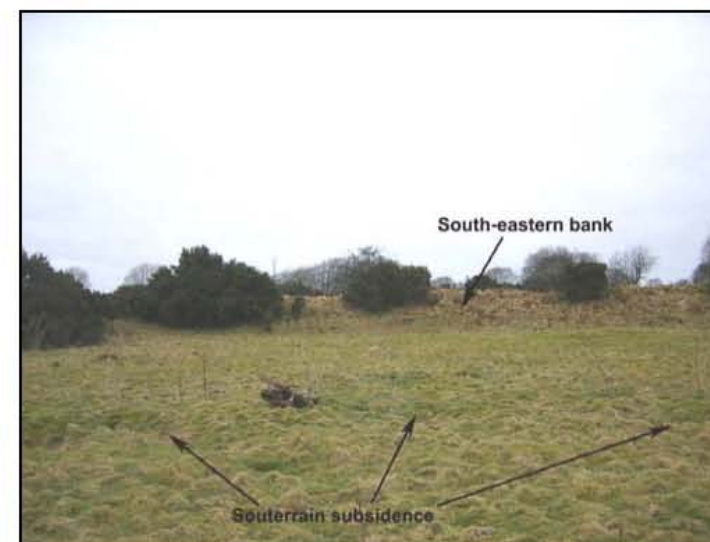
3.4 The ringfort at Burnfort is currently under rough pasture and the land within the ringfort and in the surrounding fields has not been cultivated for some time (Plate 1). The ringfort is in a similar condition to that described by Power (*ibid*). Subsidence within the ringfort enclosure, indicating the collapse of souterrains, is also as described above.

Plate 1: Ringfort interior. Looking SE.

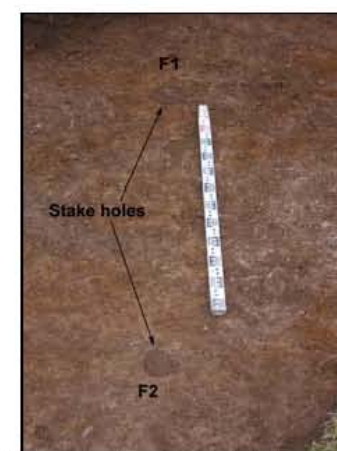
Plate 2: Test Trench 1. Stake holes, from S.

- 5.3 Since the purpose of the excavation of the test trenches was to determine the presence or otherwise of buried human remains, the possible features associated with the ringfort occupation (stake holes, possible pit) were preserved *in-situ*. These features were recorded and covered with plastic before backfilling the trench. The only indication of possible burials were the pit-like features, identified by the geophysical surveys as potentially deriving from grave cuts. However, of those features investigated by the subsequent test trenching none were shown to be related to human burials. There was no other evidence noted to suggest that the ringfort enclosure had ever been used as a burial ground.

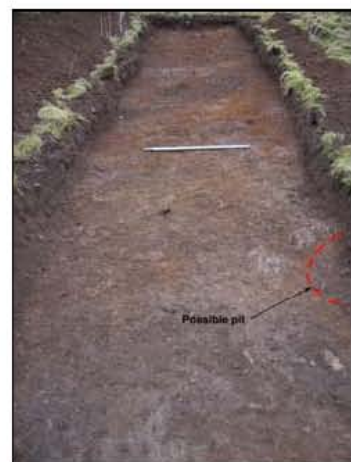
The grass sod and underlying topsoil were removed to a depth of c. 0.4m over the total area of the trench. The topsoil was a dark brown, friable and largely stoneless soil, although there was a greater concentration of stones in the soil at the northern end of the trench. Topsoil depths varied only slightly over the length of the trench with the greatest depth (0.45m) at the southern end of the trench. The soils at the base of the trench were trowelled to the underlying sub-soil which was an orange sandy boulder clay. Redeposited sub-soil was noted at both the southern and northern extremities of the trench and in patches along the eastern side of the trench and this appears to represent the redeposition of soils from the original excavation of the souterrain.

Plate 3: Test Trench 1, from SSW.

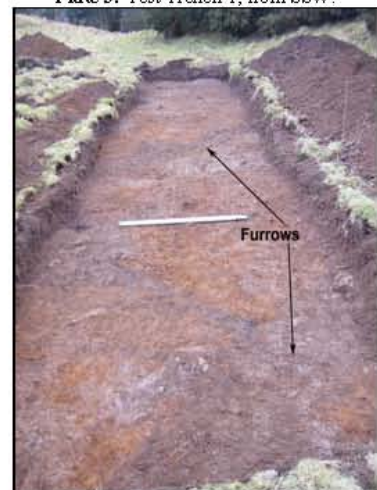
Plate 4: Test Trench 1, Furrows, from NNE.

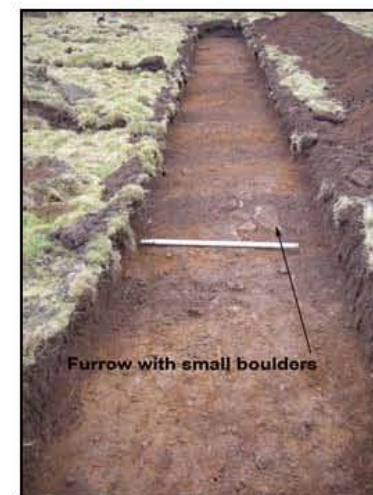
The grass sod and underlying topsoil were removed to a depth of c. 0.45m over the total area of the trench. As before the topsoil was a dark brown, friable and largely stoneless soil. The soils at the base of the trench were trowelled to the underlying sub-soil which was an orange sandy boulder clay. Seven furrows (F6-12) were noted crossing the trench (Figs 10, 11; Plate 5). Five of the furrows crossed the trench in a SW-NE direction and varied in width from 0.46m-0.63m. The furrows averaged 0.05m in depth. There was a large boulder in one of the furrows (F7). Two EW furrows at the southern end of the trench were narrower at 0.3m wide and were 0.15m in depth.

Plate 5: Test Trench 2, Furrows, from NNW.
